A+ HOME INSPECTIONS

HOME INSPECTION REPORT

Evaluation of property located at: **123 Farm Road, Anywhere, TN**
Inspection is performed for: **Mr. and Mrs. John Smith**
Time of the inspection is: **February 9, 2011 9:30 AM to 3:04 PM**

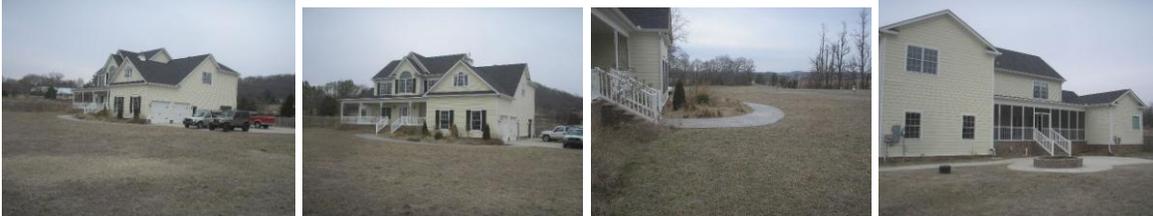
2. This home is built on a relatively flat lot, which slopes from left to right.
3. The ground should slope away from the house continuously at least one inch per foot for ten feet minimum. But, it is flat right up against the house in places on all four sides.

- 4.
5. Building codes 401.3, 406.3.5 and 1806.5.5 require the ground surface to slope AWAY from the foundation 6" minimum drop in 10'-0" of horizontal distance. It is recommended that the ground slopes away from the house at least 1" per foot for at least 10'-0".
6. Adding sloping compacted clay dirt up against house to any low lying areas around the foundation where ground settles, will help kick water away from house. Do not cover any crawl space vents with dirt or mulch. Half-circle wells may be needed around crawl space vents.

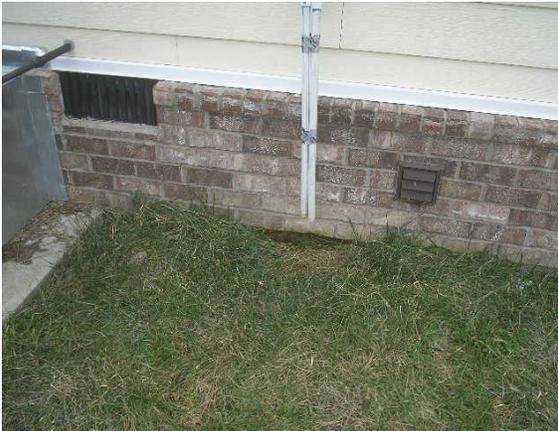
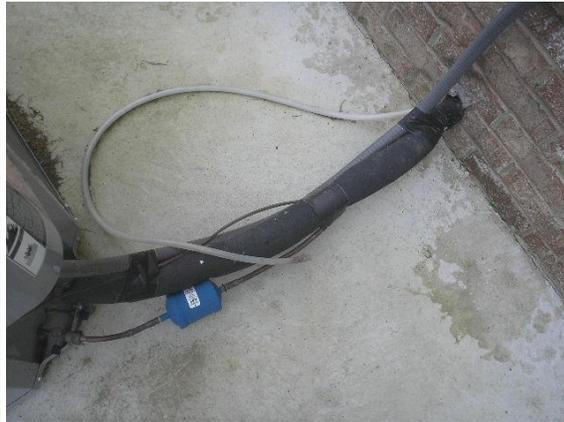
- 7.
8. It is important that roof and surface water drain away from the foundation to properly maintain the integrity of the foundation and maintain the area under the home. This includes keeping gutters and downspouts clean, and maintaining downspout extensions and splash blocks.
9. There are some water puddles in the crawl space at this time under the plumbing leaks. See CRAWL SPACE notes below.
10. Extend the a/c condensate drain lines and condensate pump hose away from the left outside of the house. They are emptying their approximately 7 or 8 gallons of water a day right up against the foundation wall.

- 11.
12. Position splash blocks better under downspouts and slope them AWAY from house.
13. Downspout extensions are preferred.

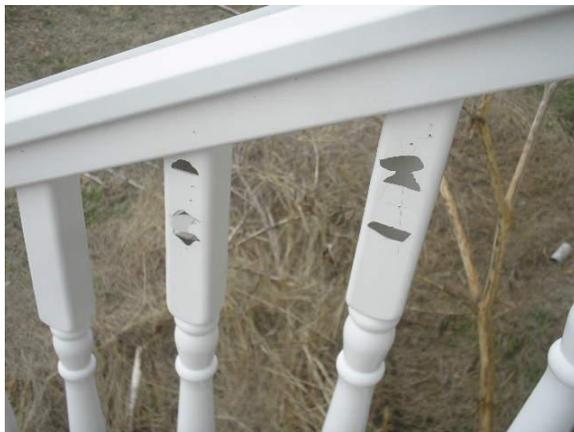
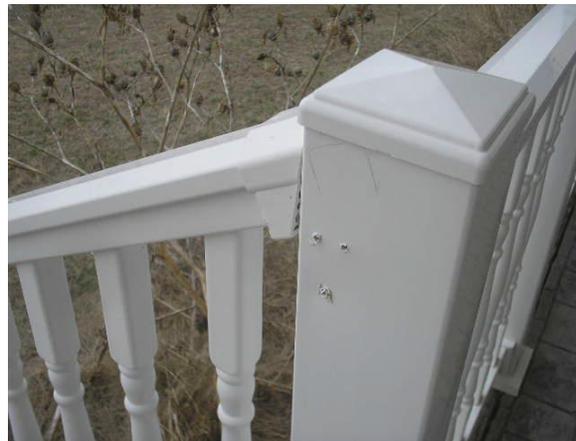
1. There needs to be a graspable handrail on the front steps. It is removed and lying near the overhead garage doors.

3. Some PVC handrail vertical pickets are broken on the front porch, like where the graspable wooden handrail is removed.
4. There are no control joints in the sidewalk, front porch or patio. So, there is random cracking here. Control joints are planned for cracks which allow for movements caused by temperature changes and drying shrinkage. In other words, if the concrete does crack-you want to have an active role in deciding where it will crack and that it will crack in a straight line instead of randomly. According to the Portland Cement Association, control joints should be placed at two times the concrete slab thickness in feet for a maximum aggregate size of less than 3/4 inch. So, if slab is 4" thick, control joints should be every 8 feet, in both directions. Space joints properly. Space joints (in feet) no more than 2 times the slab thickness (in inches). A 4" slab should have joints 8 feet apart. Cut joints deep enough. Cut joints 25% of the depth of the slab. A 4" thick slab should have joints 1" deep. Grooving tools cut joints in fresh concrete. Saw cut cuts joints as soon as the concrete is hard enough that the edges abutting the cut don't chip from the saw blade. Joints can be saw cut into concrete after it is cured too. Some existing saw cuts are too shallow to work effectively.

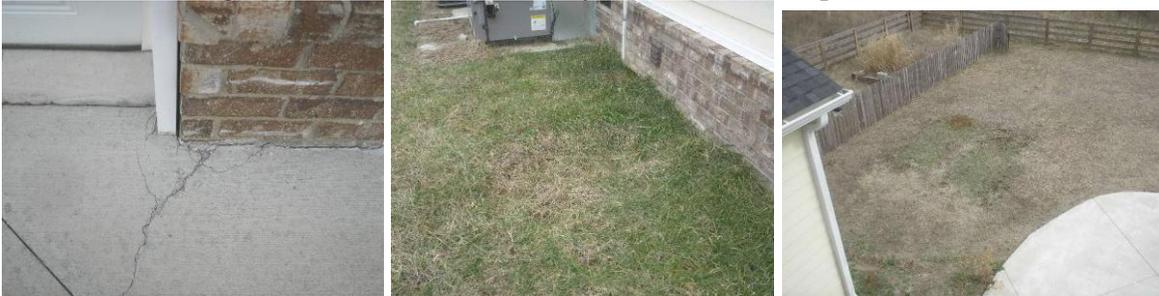
5. Common cracking noted on concrete driveway, walks and front porch.

- 6.
7. What caused the sunken spot in the yard at the left end of the house?
8. Some bare dirt noted above where it appears septic tank is in back yard.

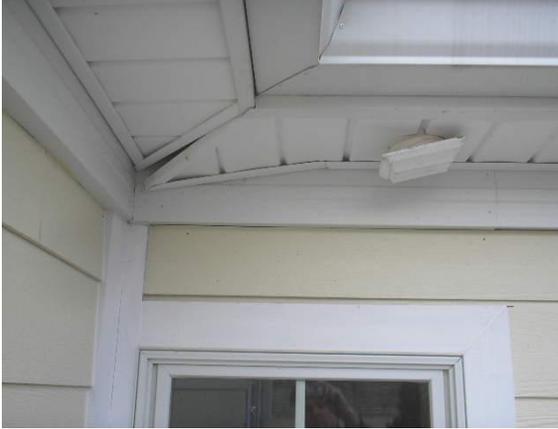
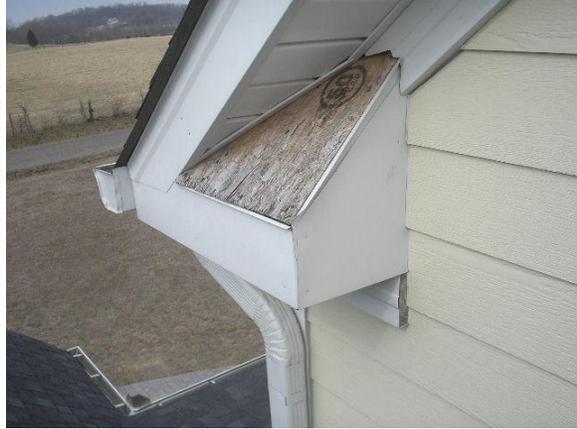
1. Rear porch screened door is torn.
2. Rear screen porch door drags.
3. Vinyl soffit is dropped down in some corners where birds can enter; like at the rear left corner of the rear screened porch.
4. Bath exhaust fan louvers are hanging out of the soffit; like above the rear porch roof.

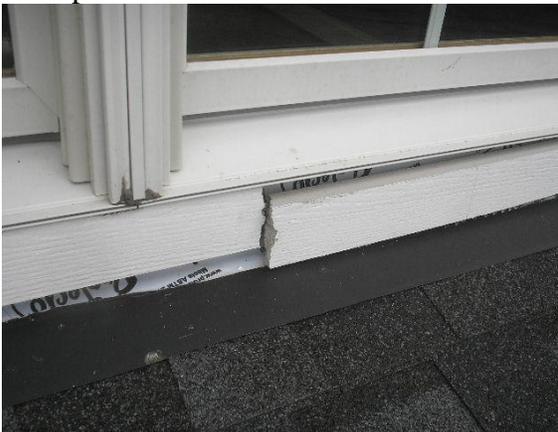
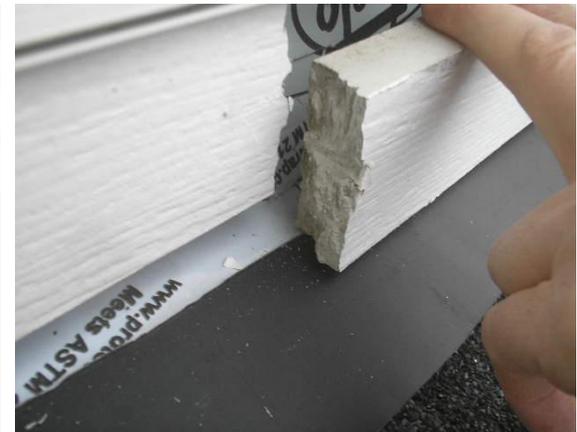
- 5.
6. Bare wood is showing where small piece of aluminum trim is missing on end of trim board below where shingles are missing on right front upstairs corner.
7. Spot of bare wood is showing at left end of centered overhead garage door where aluminum trim doesn't cover it completely.
8. Dining room window's side guide is broken off some.
9. A trim board is broken in two under the double right windows above the right end of the front porch. Secure it and seal around it.

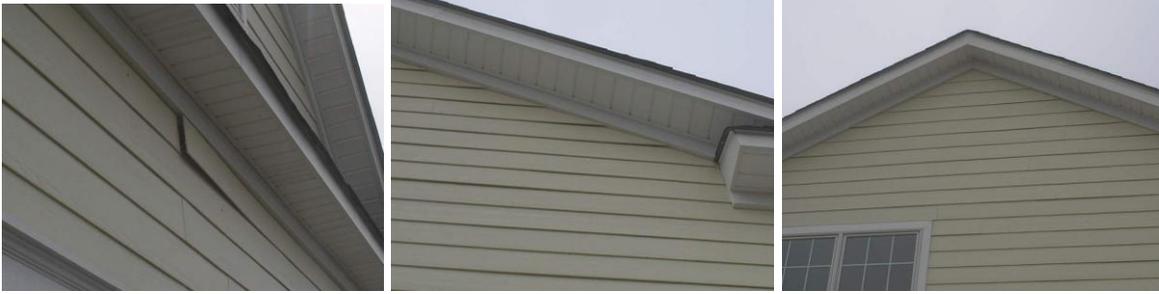
- 10.
11. Most of the window screens are missing. Some are stored in the upper attic.
12. One piece of siding has come loose on the front of the garage under the eave.

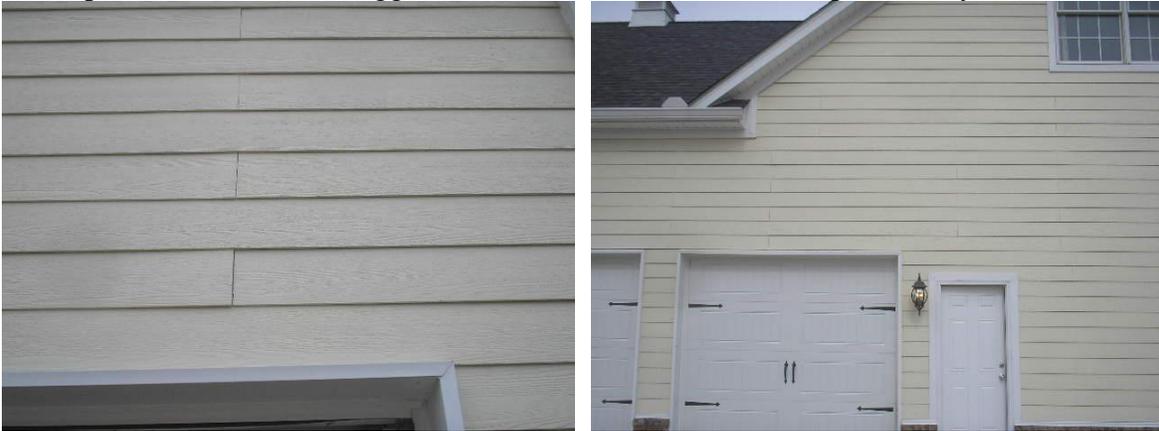
- 13.
14. The mitered ends of some pieces of Hardie plank siding are sticking out where they do not appear attached well on the gables. Since planks are attached only across their tops, the long mitered ends are sticking out where they are not attached.
15. Vertical but joints between ends of Hardie siding planks have been caulked, but have opened back up. Joints should be staggered, but a lot of these are lined up vertically.

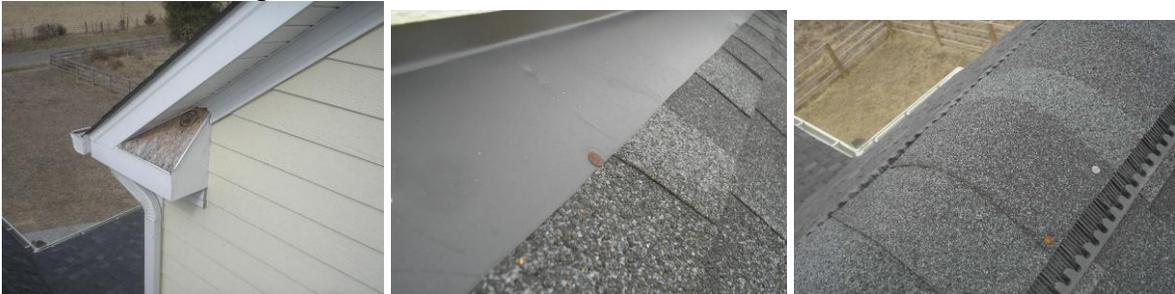
1. Roof shingles have never been put on the return on the right end of the front upstairs overhang where bare wood OSB roof sheathing is exposed. There are some extra shingles stored in the crawl space.

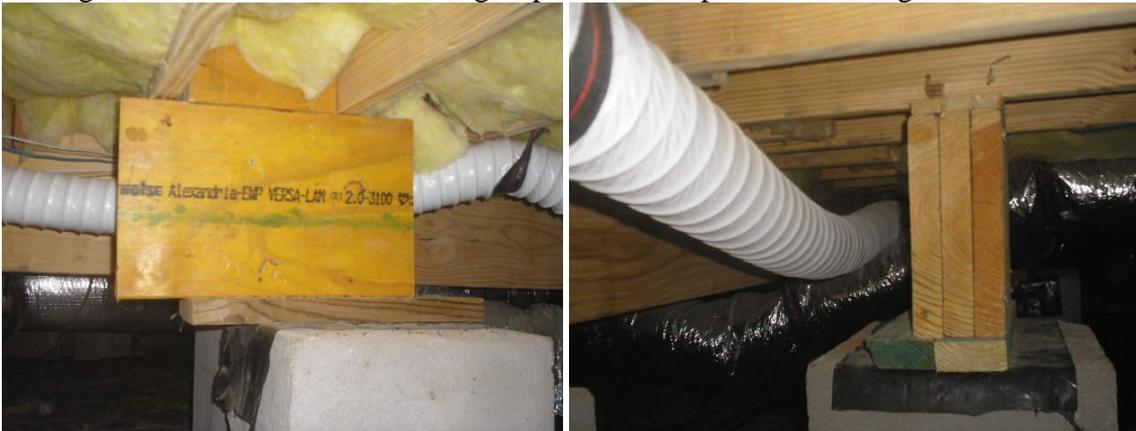
1. In the crawl space, three short wood girder beams are sitting on concrete block piers under the kitchen island area. The left wood blocking is almost off its block support where it is misaligned. Brace this wood blocking to prevent their potential leaning.

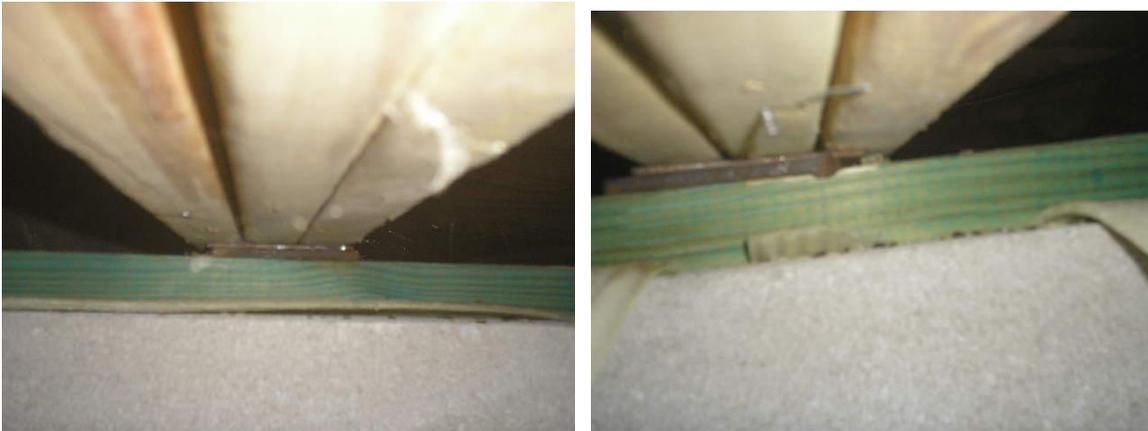
- 2.
3. Part of one member of the 3-ply wood girder beams are not fully supported on top of the concrete block piers, since only 4"x4" steel shim plates are used and the beams are about 4 1/2" wide. This is why we always recommend 4"x6" steel shim plates. Codes call for full bearing, but we see this overlooked by the code inspector on most homes.

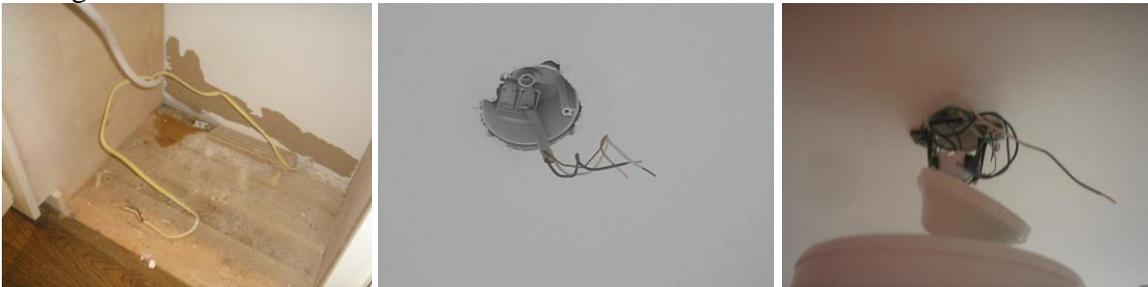
1. CAUTION! Dishwasher wire is sticking out and live where dishwasher is missing. I turned the breaker off to the dishwasher.
2. CAUTION! There are some live exposed wires where lights and fans have been removed.
3. Light fixture is missing in the loft above the half circle window. Wires are hanging out of the ceiling here.

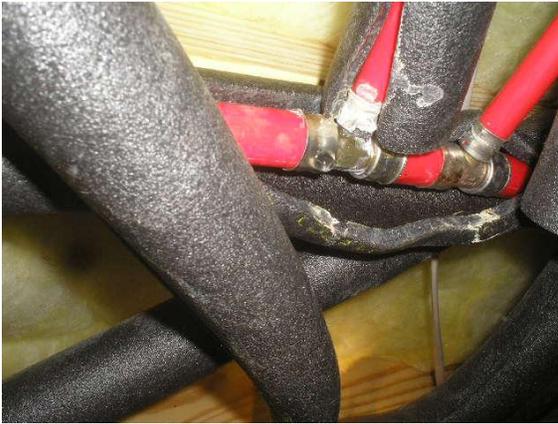
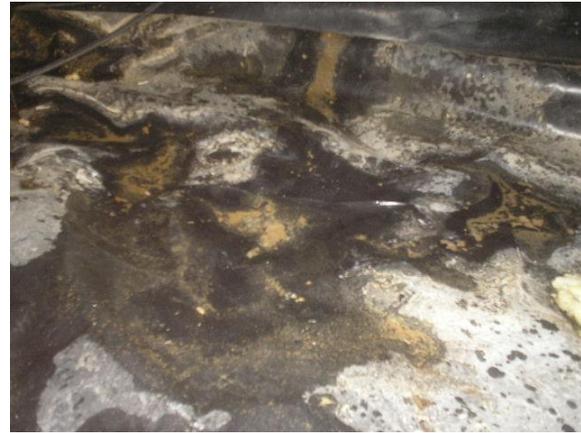
1. CAUTION! Cap the gas line at the patio.
2. As seen in crawl space, at least one red PEX water supply line is leaking below the floor joists under kitchen/laundry wall area. It drips about every two seconds. We turned the water back off to the house before we left. PEX stands for cross linked polyethylene. PEX Tubing is the most advanced and tested material available on the market today. PEX Tubing is designed for use in Radiant Floor Heating Systems and PEX Plumbing systems. It is gaining in popularity due to its ease of installation and durability.

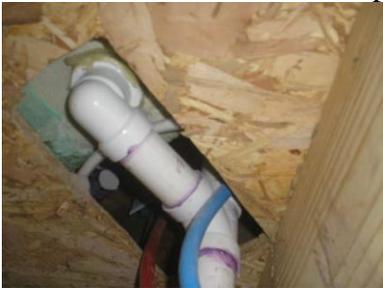
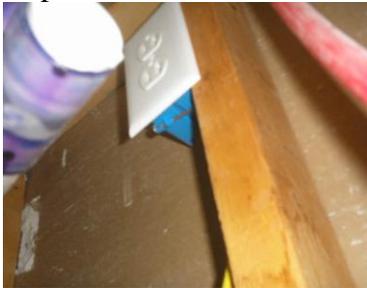
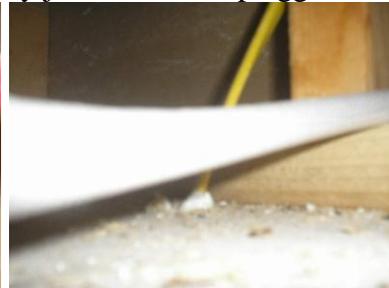
9. I could not get the master whirlpool tub to run. There is no access panel for me to see under it. I could only see an electric outlet up in the tub enclosure from the crawl space by looking through a hole through the floor. There is nothing plugged into this outlet and the pump motor usually is. I could not see the pump or its motor through this small hole. A proper access hole is needed. If the pump and motor are there, it may just need to be plugged in?

16. Ensure the bottom of the whirl pool tub is supported.
17. There should be an easily removable access panel to inspect under whirlpool tub periodically, since leaks are common here.

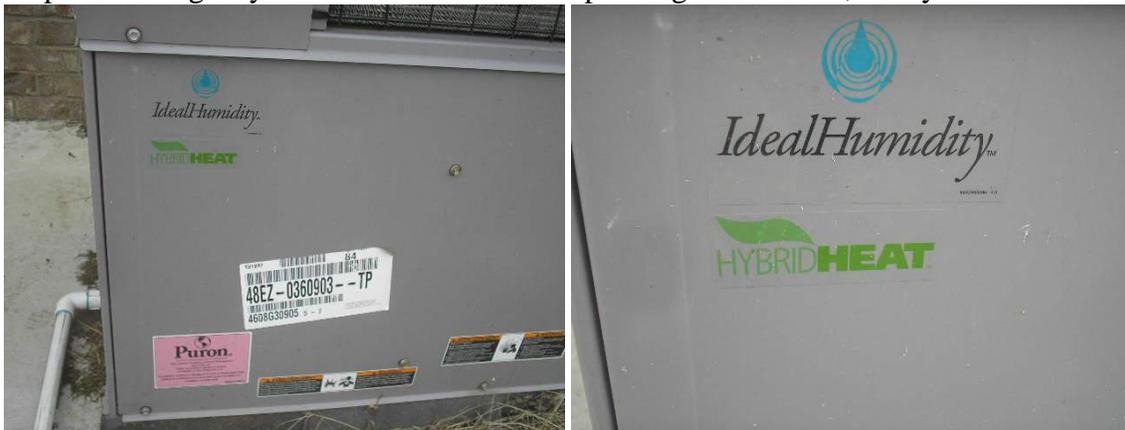
1. Investigate how the furnaces' hybrid systems work. I could not get furnaces to run in electric mode only, even when I had their thermostats set on "Em heat", which is usually electric heat strips for emergency heat. I didn't have the operating instructions, so my test was limited.

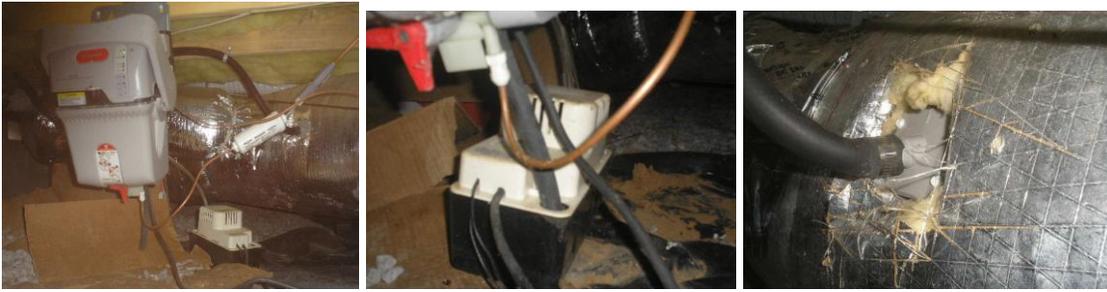
- 2.
3. Honeywell HM512A1000 True Steam direct injection humidifier in left crawl space needs to be cleaned and serviced. Its cover was partially off and its "press energy" light is blinking.

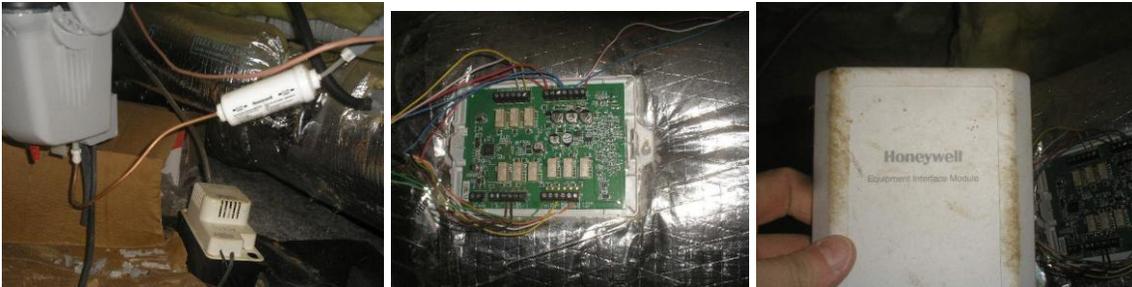
- 4.
5. Ensure humidifier is set properly since it sprays water right into the main downspouts ductwork, which may cause mold in ductwork. I often find them improperly set.
6. Use humidifier very sparingly if at all.
7. Align and secure condensate pump under humidifier in left crawl space. Its drain was not connected.

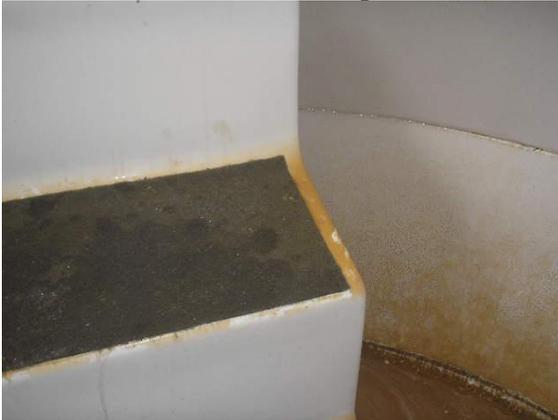
1. Tornado room in rear garage slab has about 4" of water standing in its bottom. Where did this water come from? Pump water out.

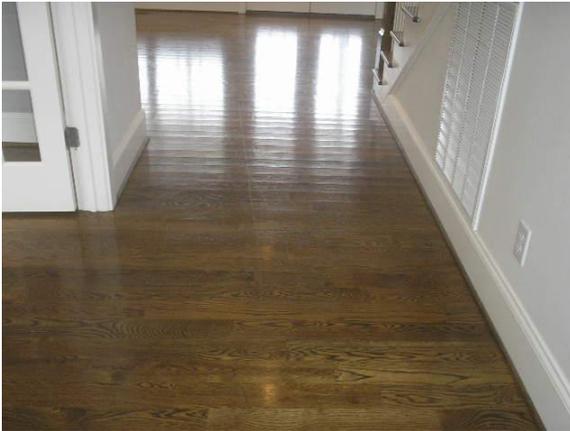
1. Cupping noted on hardwood floors is usually from excess moisture in crawl space.

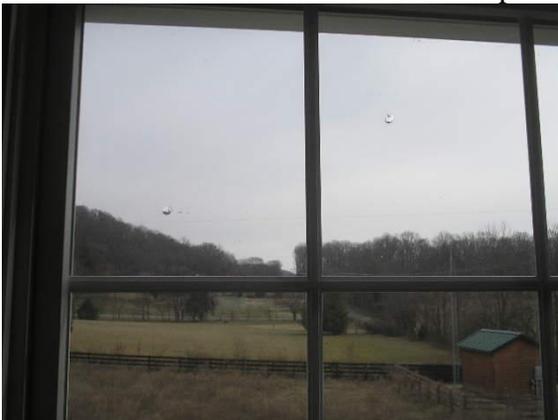
1. Door doesn't latch.
2. Lock doesn't work on the door.
3. Two BB sized holes noted in the outer pane of glass on the upper sash of the left window.

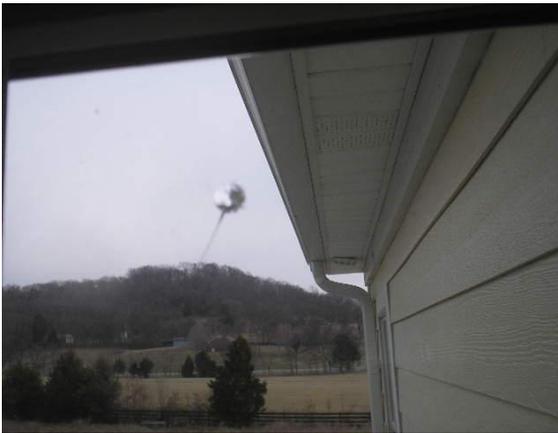
1. Hole noted in the outer pane of glass in the top sash of the window. It appears to be a BB hole.

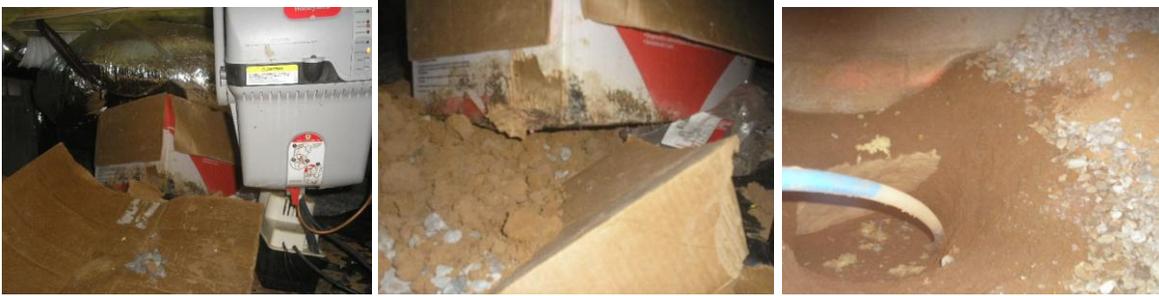
plywood scraps are often found on the ground where the sub-flooring is cut out for each of the air supply vents through the floor. Metal termite shields are not seen here and are rarely seen anymore. Cardboard is in left crawl at humidifier.

- 11.
12. Backfill holes and cover ground with 6-mil plastic in left front crawl space where blue water line enters and was not used.
13. The ground is covered pretty well with 6-mil plastic vapor barrier, but there are some bare areas that need to be covered better. It is preferred that the plastic be sealed at its edges and seams. Ensure it remains covered wall to wall to help reduce mold and mildew. Overlap seams and provide extra at walls.

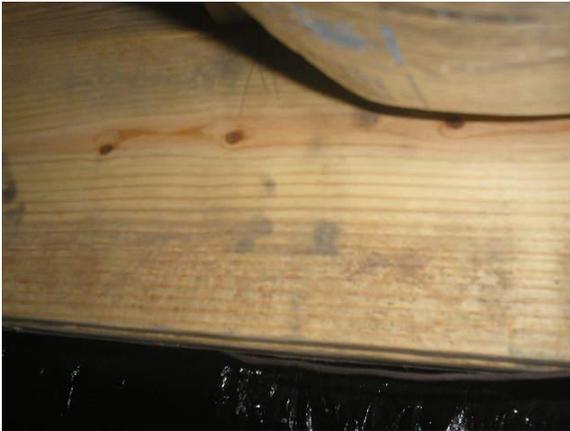
1. There is a common trace of mold-like substance on some of the exposed portions of the wood floor joists and beams. Some of it may be mud. It appears worse above the water puddles and bare ground. After water is removed, you could consult a mold specialist.

- 2.
3. Per a specialist I know, it is best to remove the mold than to treat it with Tim Bore or Bore Care like several pest companies now do.
4. Mold is a fungus---a parasitic plant lacking chlorophyll, a rigid cell wall, leaves, true stems & roots. Mold is multicellular, and it is composed of thread-like hyphae.
5. Molds spores can cause serious health problems even if the spores are dead or dormant (inactive while waiting for more moisture to resume growth).
6. Even the smell of dead or dormant mold can make some mold-sensitive persons ill.
7. There are no legal mold exposure limits.
8. Sampling for mold can be referred to a qualified microbiologist.
