A+ HOME INSPECTIONS

HOME INSPECTION REPORT

Evaluation of property located at: **123 Farm Road, Anywhere, TN**
Inspection is performed for: **Mr. and Mrs. John Smith**
Time of the inspection is: **February 9, 2011 9:30 AM to 3:04 PM**

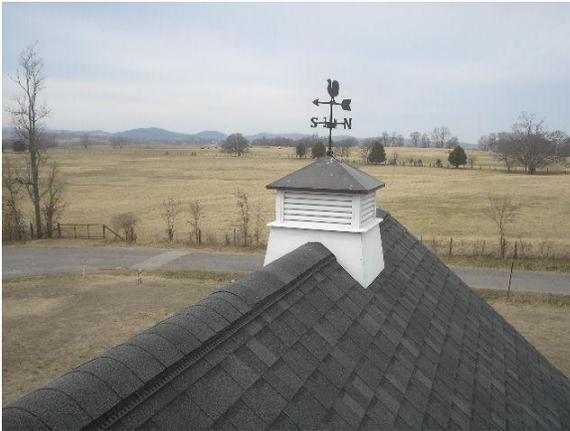
- 16.
17. Seal all holes through walls to keep mice out.
18. Caulk the bottoms of all wood doorjamb, around doors, windows, and door thresholds as needed regularly.
19. Caulk the bottoms of all wood doorjamb.
20. Caulk around doors, windows, and door thresholds.
21. Common cracking noted on the front porch.
22. Caulk around outside of overhead garage doors.
23. Caulk and paint wood on cupola better on front right roof.

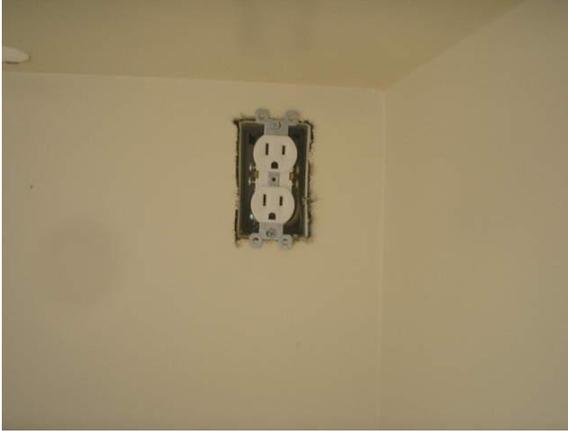
8. Cover is missing off the outlet on the left end of the porch.
9. Cover plate is missing on the outlet in the cabinet in the bonus room.
10. Get all lights working. Following are some of the lights which were out at this time:
11. Two front porch lights are out.
12. One light is out in the rear right upstairs bedroom closet.
13. One light is out in the garage ceiling.
14. Bulb is missing in the left attic at the bonus room.
15. One light is out in the pantry closet.
16. One light is out in the rear right upstairs bedroom closet.
17. One bulb is missing in the left crawl-in attic.
18. I did not see flood lights come on. They may be on photocells/motion sensors.
19. Install all cover plates and their screws on outlets, switches and junction boxes.

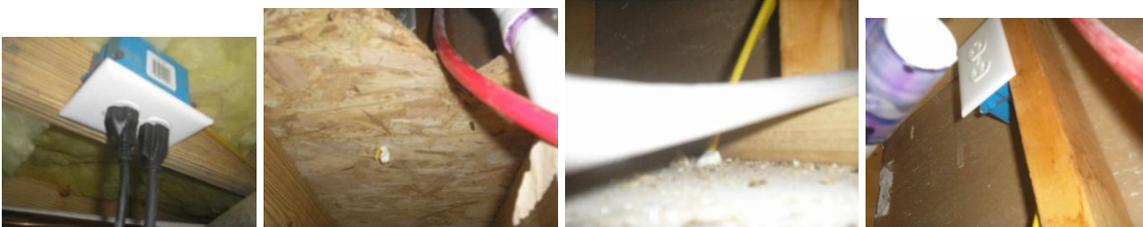
- 20.
21. It is not recommended to plug a refrigerator or freezer into the GFCI protected outlet in the garage, since its compressor can trip the GFCI. I did NOT see a separate non-GFCI protected wall outlet here for it.
22. Ensure the master whirlpool pump motor housing is grounded if it is metal. It often is not and should be.
23. In left crawl space, electric outlet for humidifier and condensate pump is NOT GFCI protected and it should be per codes. However, if it trips, water may enter crawl space.

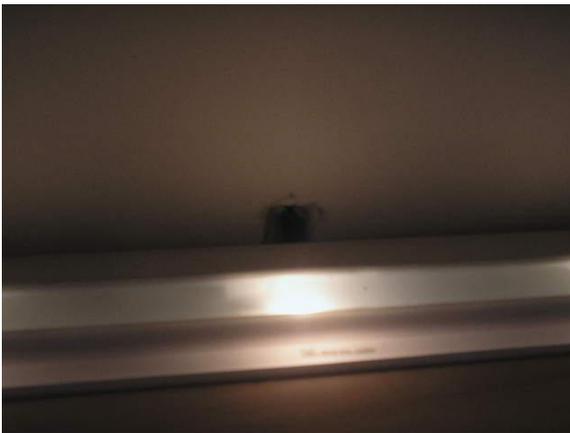
5.

1. Dishwasher and its drain hose is missing.
2. Dishwashers are complicated and get used a lot. They may fail without warning at anytime.
3. Doorstop is missing for the pantry door.
4. Patch holes through drywall above upper kitchen cabinets where wires go to lights on top of cabinets.

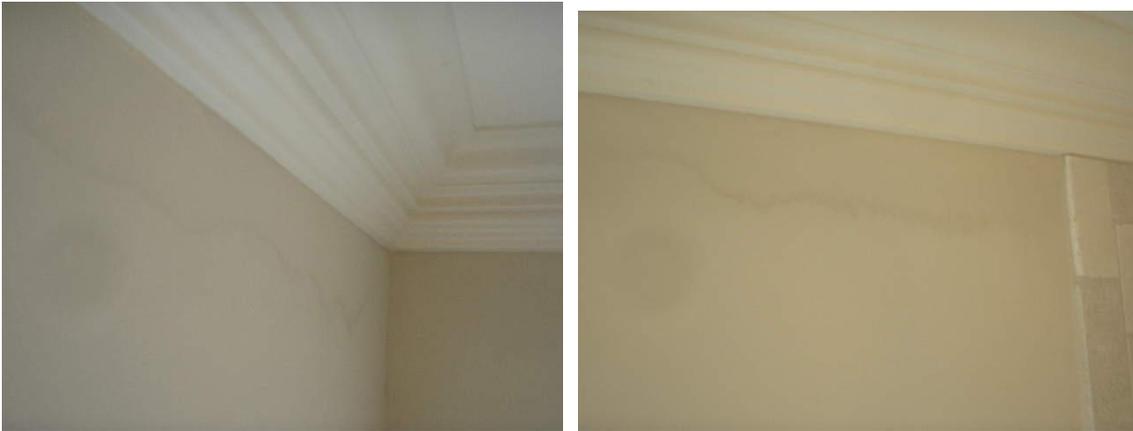
1. Tub does not run.
2. Need access hole to under tub.
3. Common cracking noted on tile work around tub.
4. There are a lot of dead wasps in the light above the commode. Screen it better from outside eave vent. Light is out.
5. Stains noted around top of walls. It appears it may be soot from candles in the high humidity. Always run bath exhaust fans to vent out shower humidity and limit use of candles.
